**Hydrologic Implications of Potential Dam Removals From Baldwin Creek,
Cuyahoga County, Ohio**

Morgan La Vallee

University of Akron

6 May, 2011

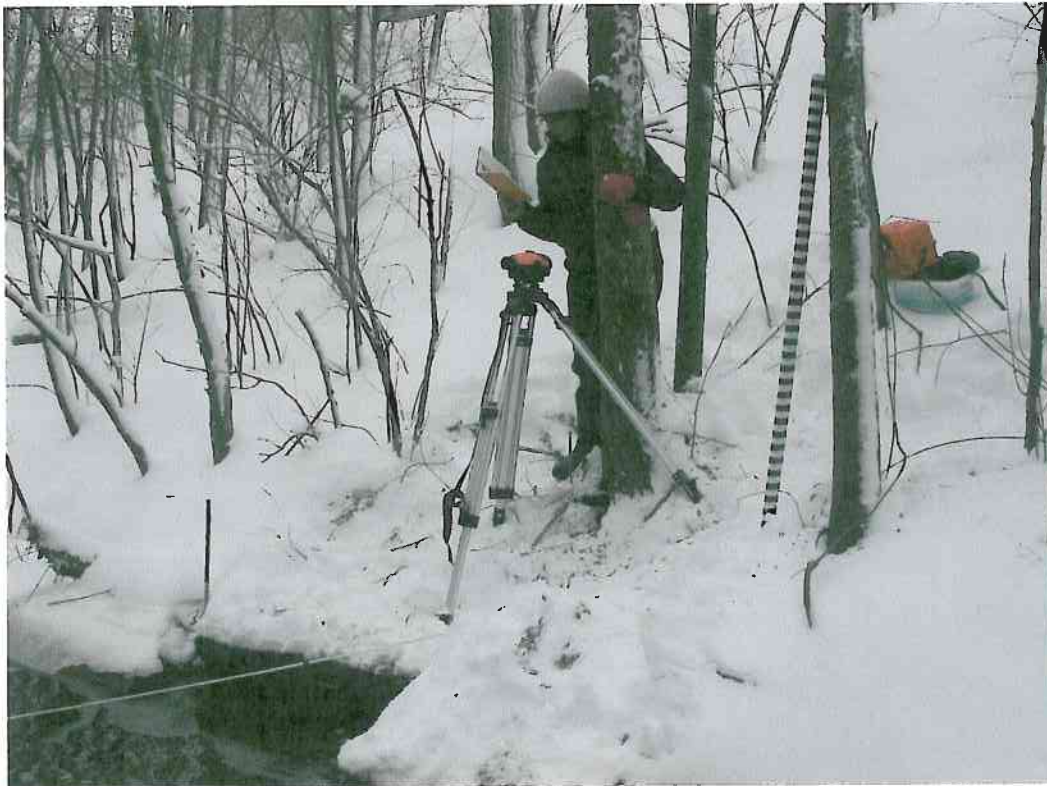
Figure 2. Measuring the river cross-section at transect-1 using a transect and stadia rod.

River cross sections were measured with a transect and stadia rod. First, we set up the transit and installed a rope across the width of the channel. The cross-section and water depth were measured using a stadia rod (Figure 2). These locations were surveyed, one in the Dam 1 pool and two upstream of Dam 3 (Figure 3). Next, we measured the water surface slope by taking stadia rod readings up and downstream from the cross section location. Then, we measured the water flow at one minute intervals along the rope, using a Gurley Pygmy current meter held 0.4 m off the bottom. Afterwards, we measured suspended sediment using the Ohio sediment stick. Sediment thickness was measured using a metal probe rod (Figure 4), water depth was measured with a meter stick, the latitude and longitude of the samples was measured with a global positioning system, and the temperature of the water measured with an electronic thermometer.

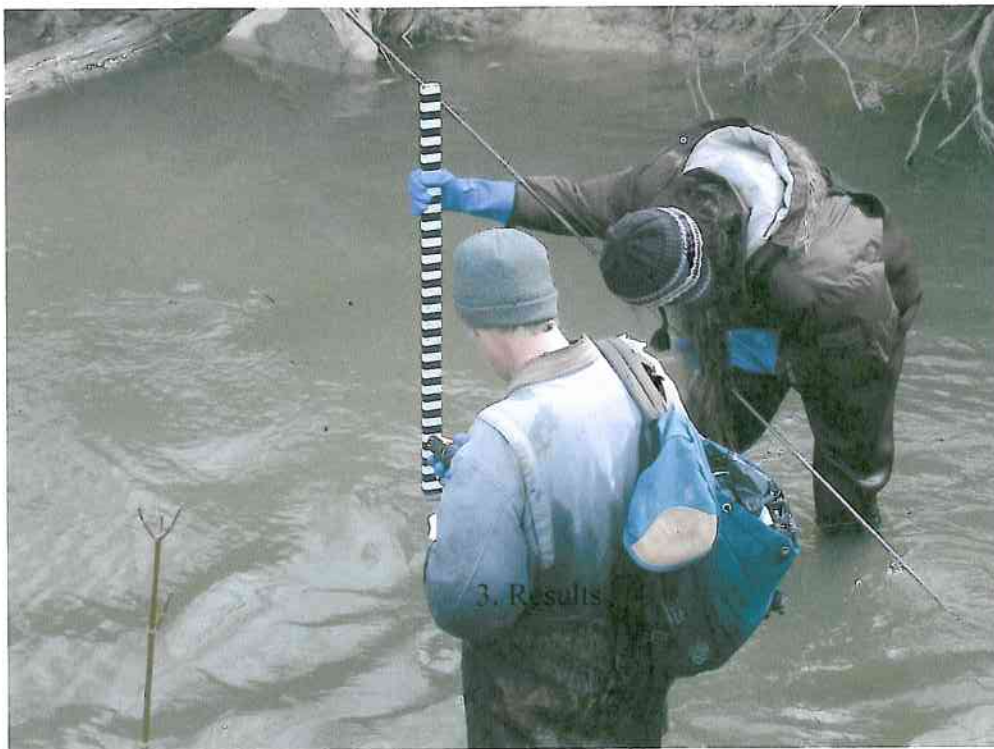
Figure 4. Measuring water depth and sediment thickness with a meter stick and metal probe rod.

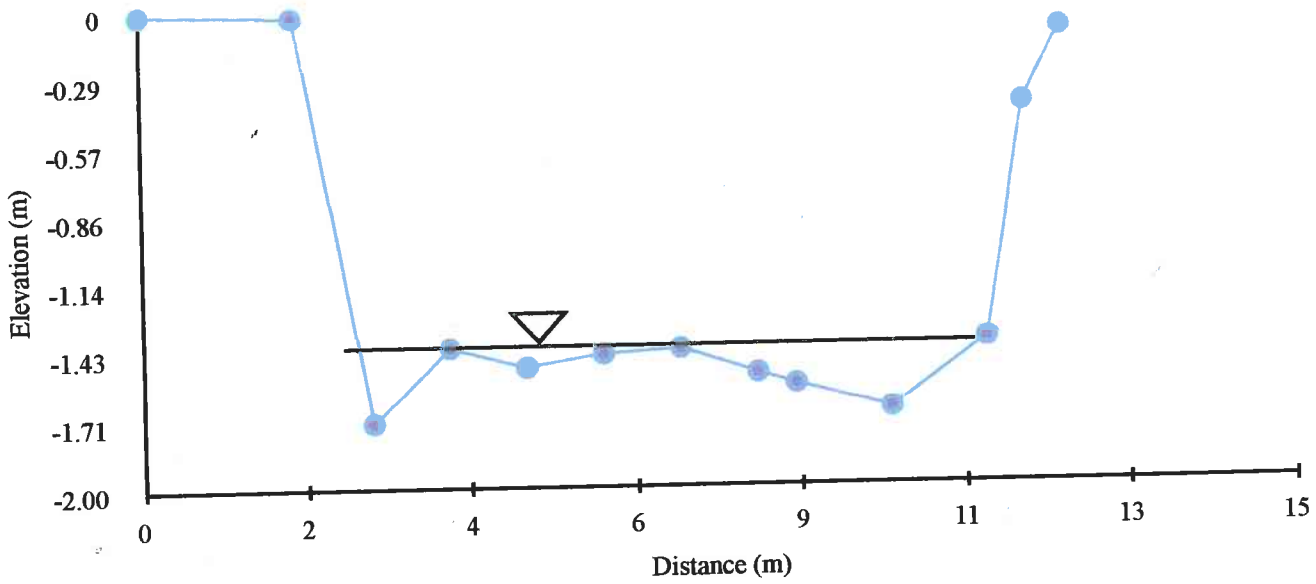
Figure 7. Graphs of the geomorphology (top), flow (middle), and suspended sediment (bottom) collected from upstream of Dam 3 of Baldwin Creek on March 14, 2011. Viewed looking upstream.

Transect 3 is located upstream of the Dam 3 pool. The data shows the channel geomorphology with a range of velocities, averaging at 0.729 m/s (Figure 7). Other measurements from this transect are in Table 7. The average slope is 0.00007954 m/m (Table 8), the D50 is 0.00365 m and the D84 is 0.0120 m (Table 9). The Calculations (Table 6) include the width (w), depth (d), wetted perimeter (Pw), velocity (v), slope (s), median grain size (D50), large grain size (D84), Reynolds number (Re), Froude number (Fr), shear velocity (U*), bed shear stress (t), shields parameter (O), Reynolds number for particles (Rep), stream power, and relative roughness.
