# Cahoon Creek-Frontal Lake Erie (HUC-12: 04110001 02 04)

## Nine-Element Nonpoint Source Implementation Strategy Plan (NPS-IS)

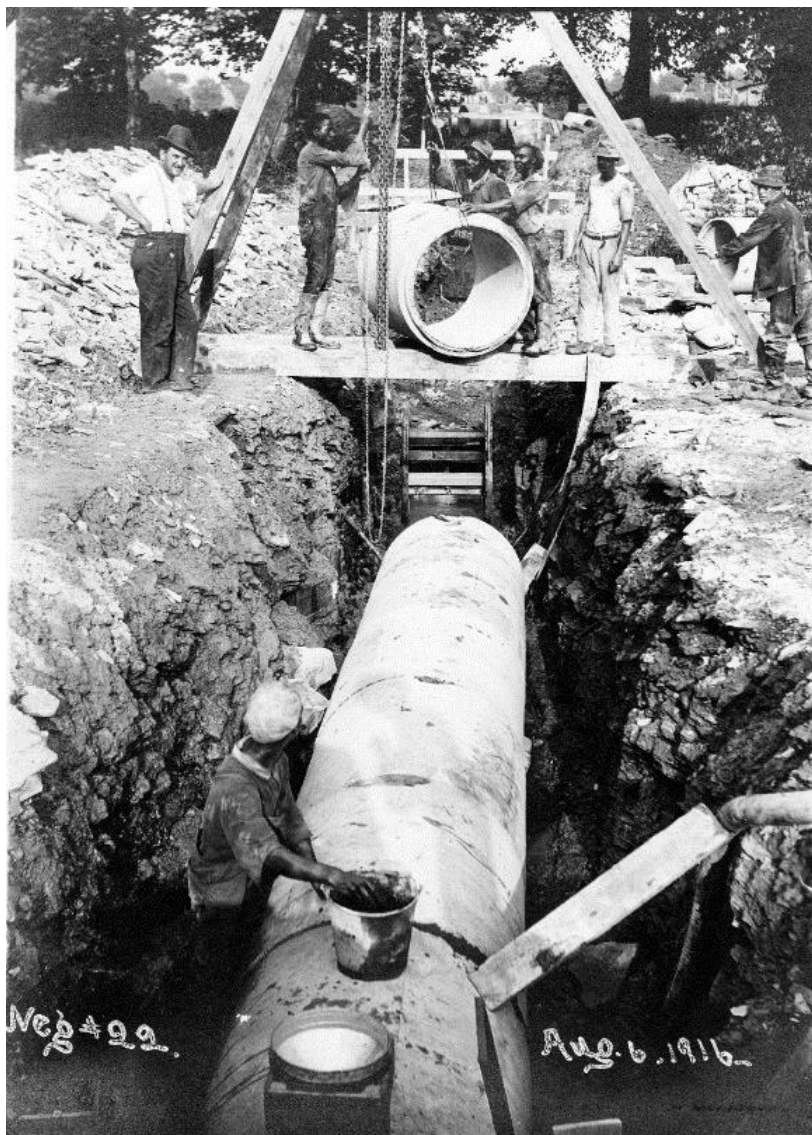
Figure 2: Sewer installation in City of Lakewood, 1916. Source: [www.onelakewood.com](http://www.onelakewood.com)

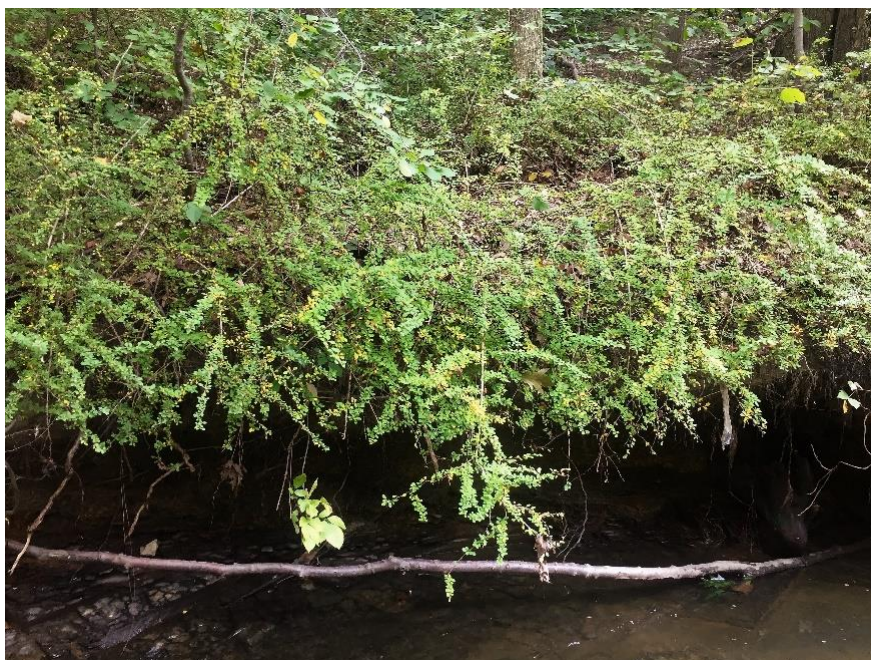
Invasive species are a significant concern in this HUC-12. For example, Cleveland Metroparks has signage posted at Huntington Reservation asking visitors not to spread Lesser Celandine. Near the mouth of Cahoon Creek, large amounts of Japanese barberry (*Berberis thunbergii*) and Japanese knotweed (*Fallopia japonica*) were identified during a survey on September 12, 2018.

Figure 7: Japanese barberry along bank of Cahoon Creek. (Source: Alicia Beattie, September 12, 2018).

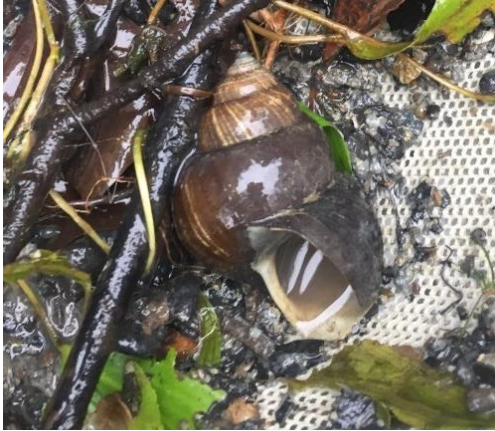
Invasive aquarium snails were also noted during an aquatic invertebrate survey on September 12, 2018.

Figure 8: Invasive aquarium snail. Porter Creek at Avon Road. Source: Alicia Beattie, September 12, 2018.

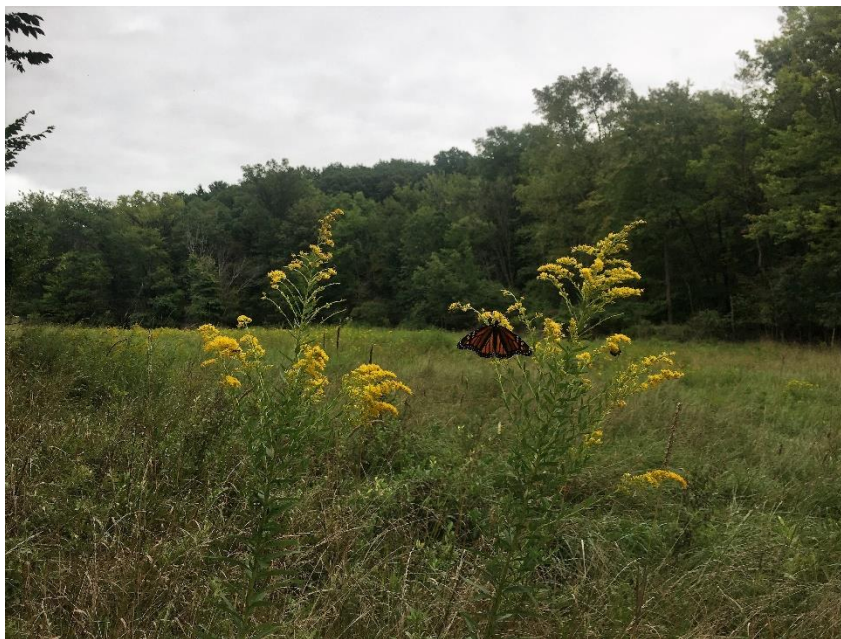
Park areas that have been preserved provide important habitat for wildlife. Many of these parks, such as at Cleveland Metroparks properties, retain forested riparian cover and include pollinator meadow rehabilitation efforts.

Figure 11: Pollinator meadow at Huntington Reservation. (Source: Alicia Beattie, September 12, 2018).

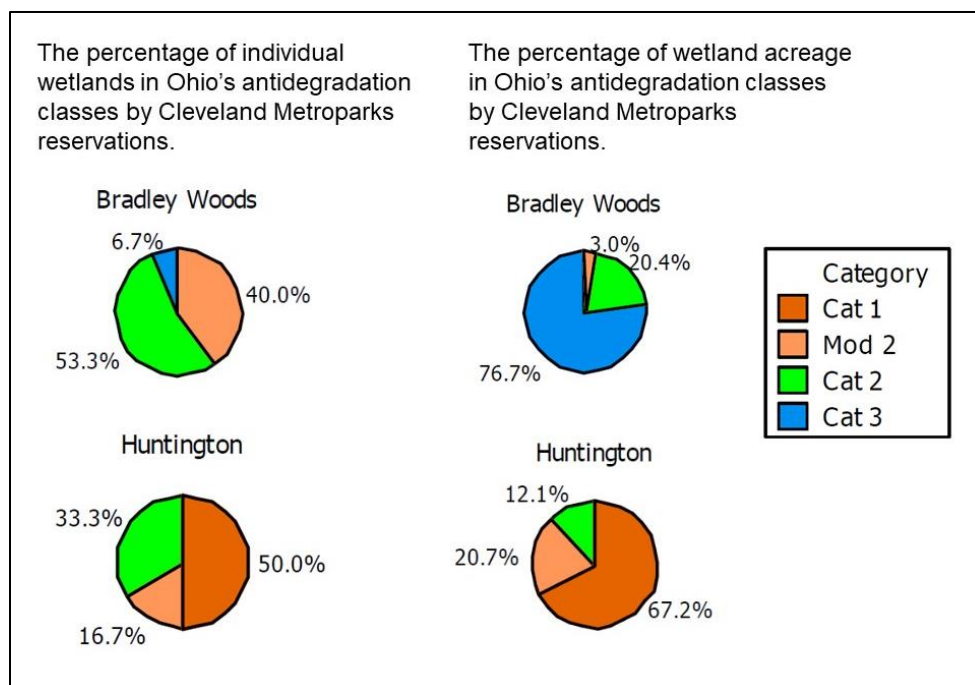
Huntington Reservation has an average Ohio Rapid Assessment Method (ORAM) score of 40 and Bradley Woods has an average score of 49. Huntington Reservation has a relatively high percentage of wetland acreage scored as Category III (Durkalec *et al.* 2009).

Figure 13: ORAM Scores for Huntington and Bradley Woods Reservations (Source: Durkalec et al. 2009).

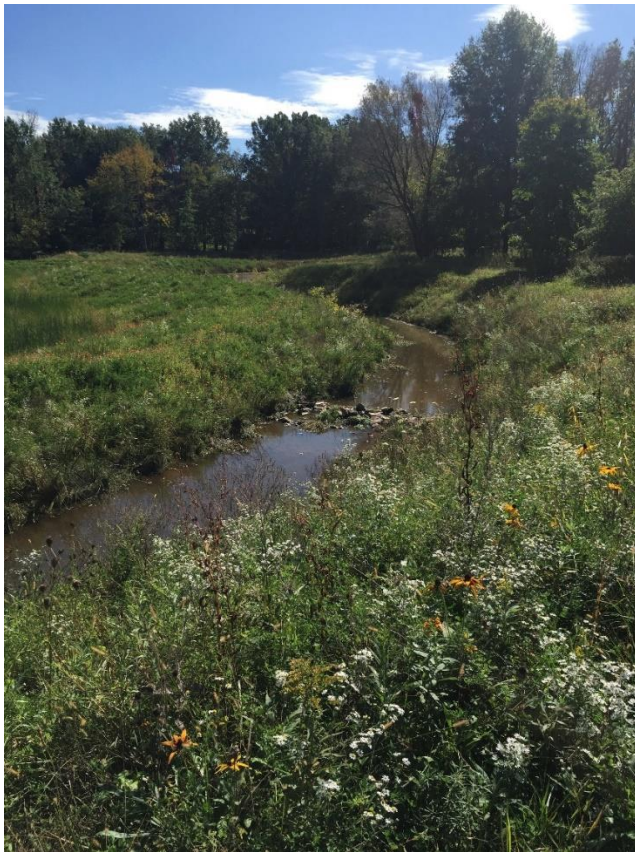
essential contributors to stream health.” The City of Westlake began a \$2.2 million riparian corridor restoration project in fall 2017 that protects and enhances Dover Ditch. This project involves land jointly owned by the City of Westlake and MetroHealth, southeast of Center Ridge and Crocker Road. Dover Creek was formerly an urbanized linear channel flowing through an ill-maintained landscaping dumping ground. The existing stream was restored to include a natural riparian corridor and water settling basins. Native wetland and upland seed mixes were used to restore plant diversity. Sinuosity was also improved, with the channel increasing in length from 2,000 feet to 2,750 feet. The project included the removal of concrete weirs within the channel and creating floodplains on both sides of the new channel. The City of Westlake also enhanced public access with this project by creating a multi-purpose trail and observation deck along the north section of the project. This new trail connects Westlake Sports Park, Evergreen Cemetery (a State of Ohio Historical Landmark), the City-wide bike path, Crocker Road (potential greenspace), a future Metro Health building, and the Westlake Community Service Center. A Conservation Easement protects the entire ~ 20-acre nature preserve from future development.

*Figure 15: Dover Ditch Restoration Project. Photo taken by Jaimie Johnson, Cuyahoga SWCD. October 10, 2018.*

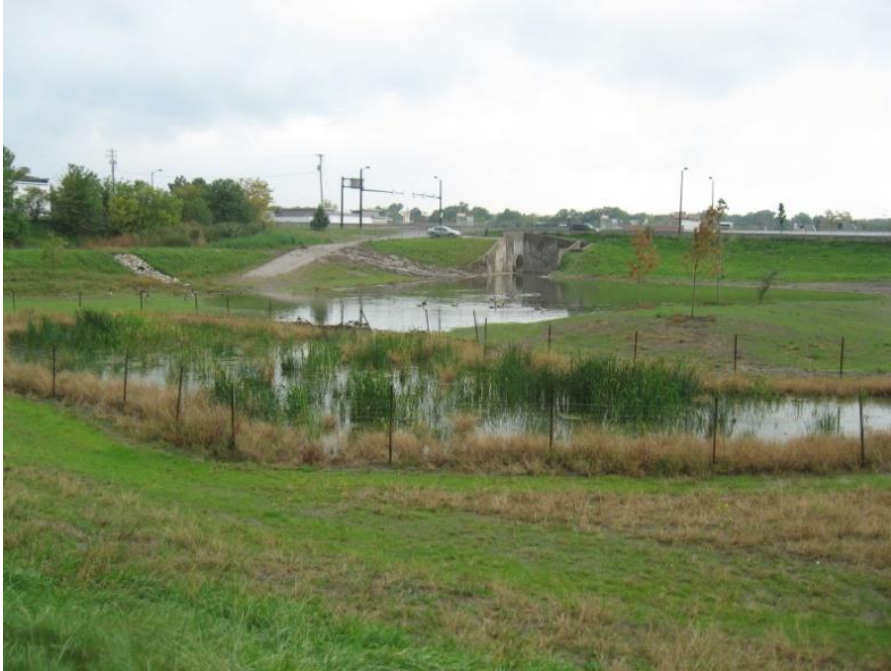
Previous projects in the City of Westlake include Porter Creek Restoration (Crocker Basin), Ehle Lateral (Southbridge Basin) funded by the Surface Water Improvement Fund (SWIF), and Wolf Creek (Columbia Basin), also funded by SWIF.

*Figure 16: Crocker Road Detention Basin retrofit, City of Westlake (Source: Dan Bogoevski, Ohio EPA)*

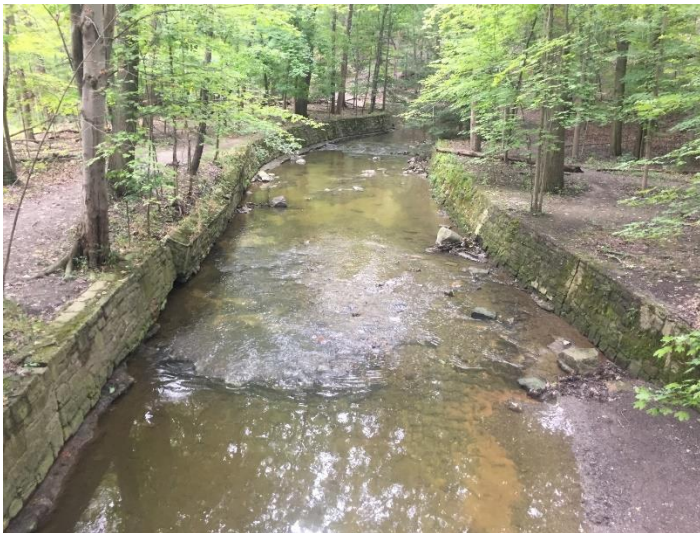
This HUC-12 has a long history of modifications to streams. There is a historical stone bank retention wall along Porter Creek that is in disrepair at Huntington Reservation.

*Figure 17: Retaining walls at Huntington Reservation (Source: Alicia Beattie, September 12, 2018).*

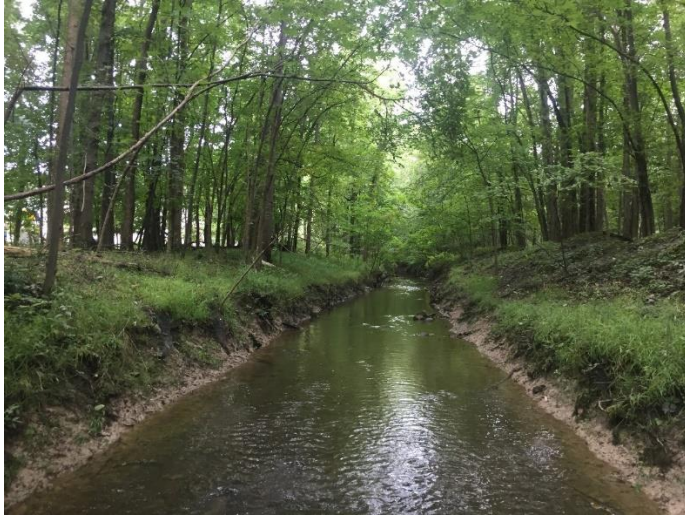
Many sections of streams in this HUC-12 were channelized in the past and have low biological diversity.

*Figure 18: Porter Creek at Avon Road (Source: Alicia Beattie, September 12, 2018).*

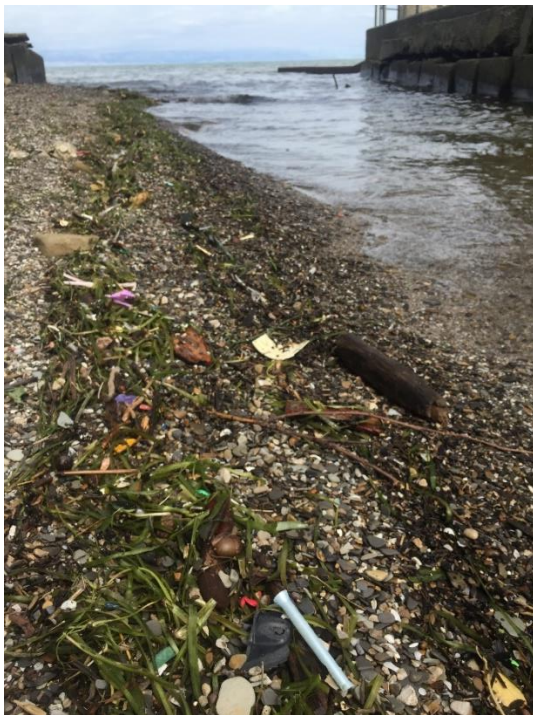
Plastic debris is also a significant concern in this HUC-12. Plastic debris often washes up on the Lake Erie shore and along the mouths of creeks.

*Figure 19: Plastic debris at mouth of Cahoon Creek at Cahoon Memorial Park. Source: Alicia Beattie, September 12, 2018.*

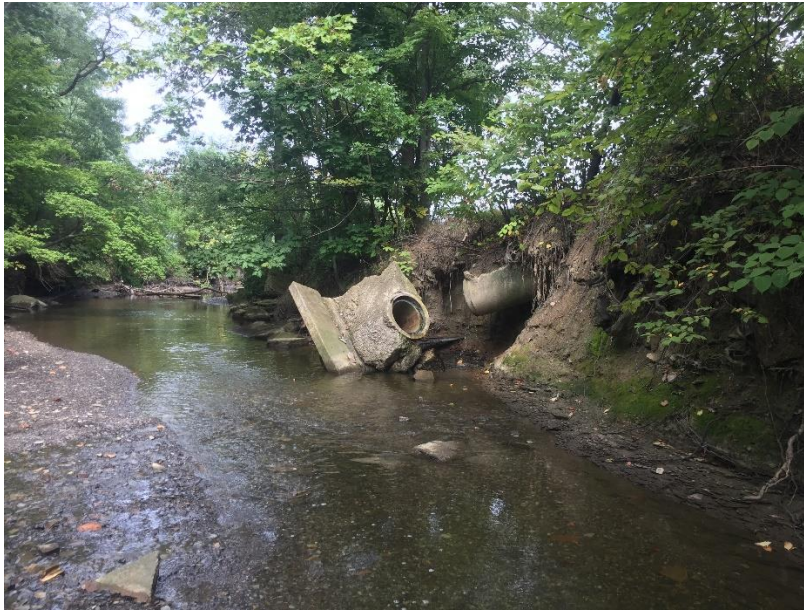
With the large amount of impervious cover and associated stormwater, erosion and failing infrastructure are of concern in this HUC-12.

Figure 20: Failed pipe outlet near mouth of Cahoon Creek (Source: Alicia Beattie, September 12, 2018).
